UNDERWATER BRIDGE INSPECTION REPORT

STRUCTURE NO. 36519

STURGEON RIVER

DISTRICT 1 - KOOCHICHING COUNTY

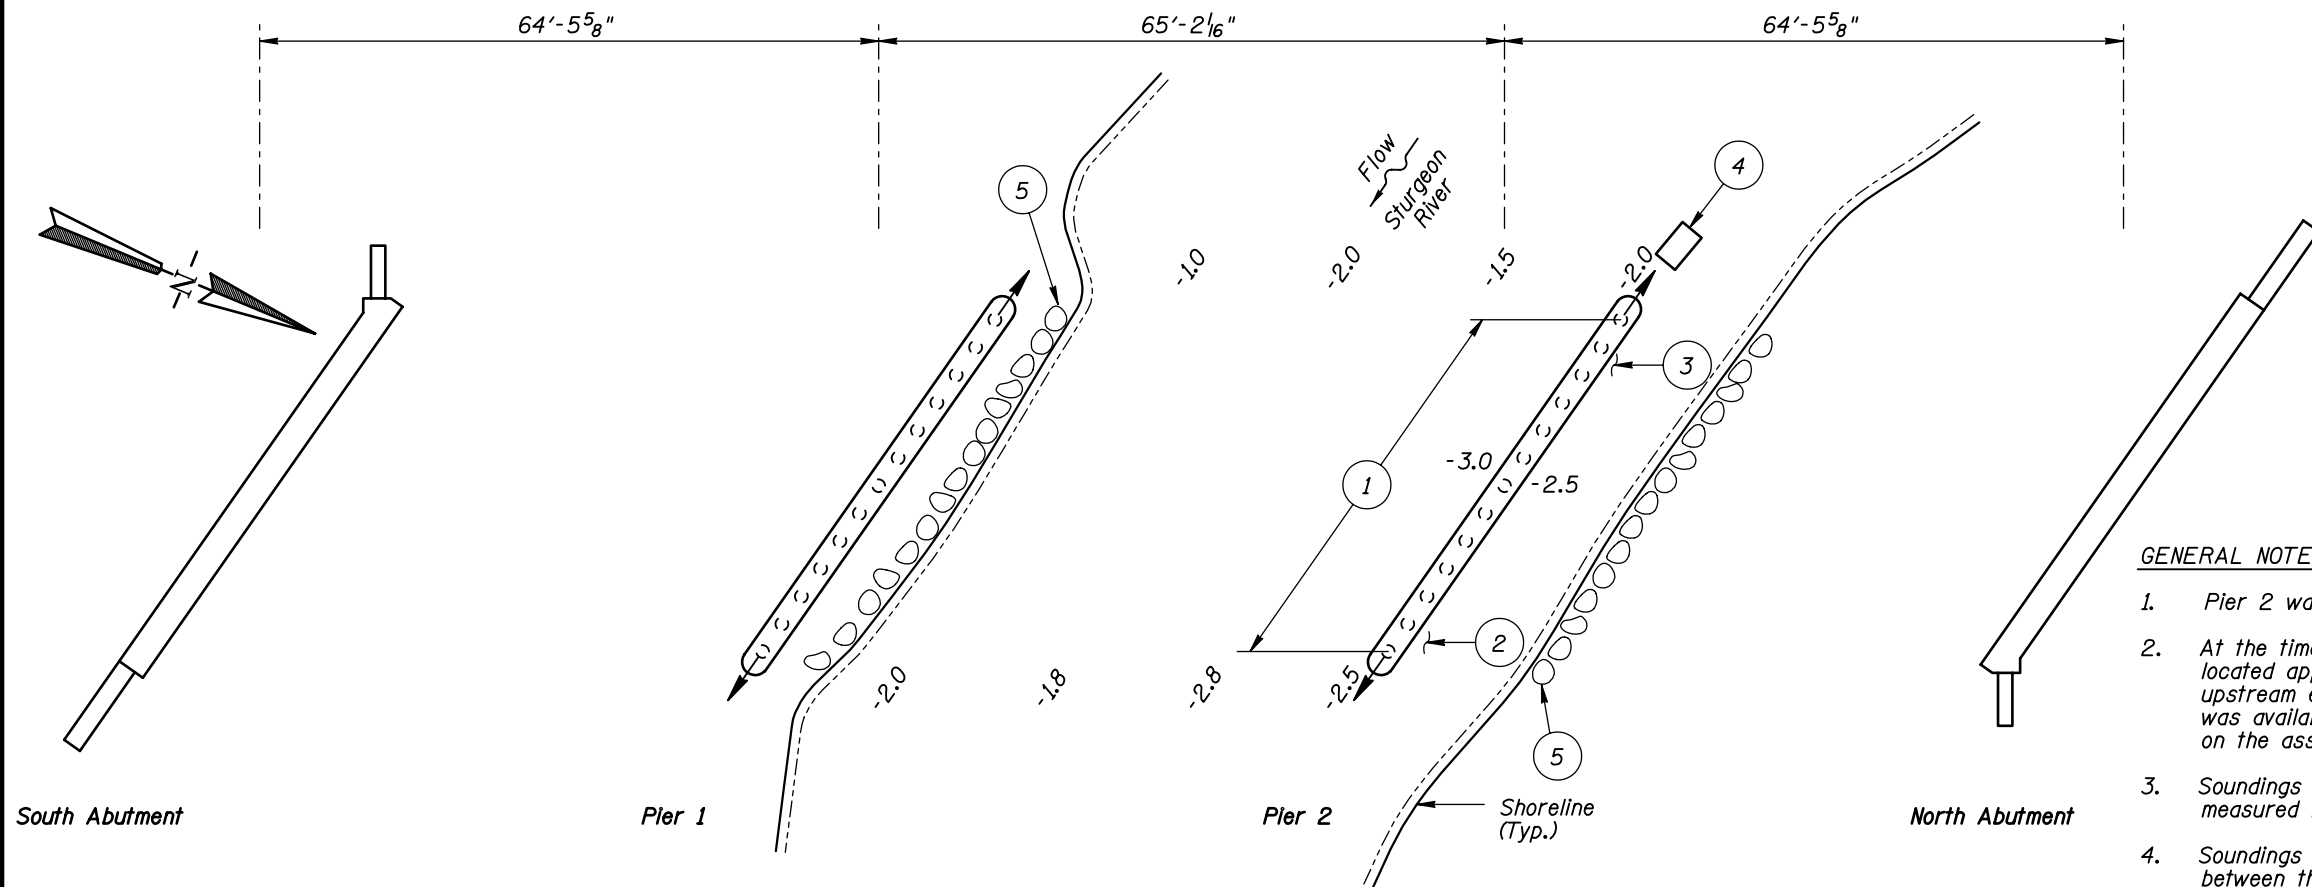
Date: AUG. 2002
Scale: NTS
Figure No.: 1

- 1 The top coat on the steel encased concrete piles exhibited 100 percent failure from 1 foot above the waterline to the channel bottom exposing the prime coat or bare steel which exhibited light corrosion on 10 percent of the exposed steel surface area.
- 2 The channel bottom consisted of sandy gravel with 6-inch-diameter cobbles and probe rod penetrations from 3 to 6 inches along the downstream half of the pier.
- 3 The channel bottom consisted of 1-foot-diameter and smaller cobbles with no probe rod penetration along the upstream half of the pier.
- 4 An air conditioning unit was observed on the channel bottom at the upstream nose of the pier.
- 5 A narrow band of 1-foot-diameter cobbles were observed along the shorelines.

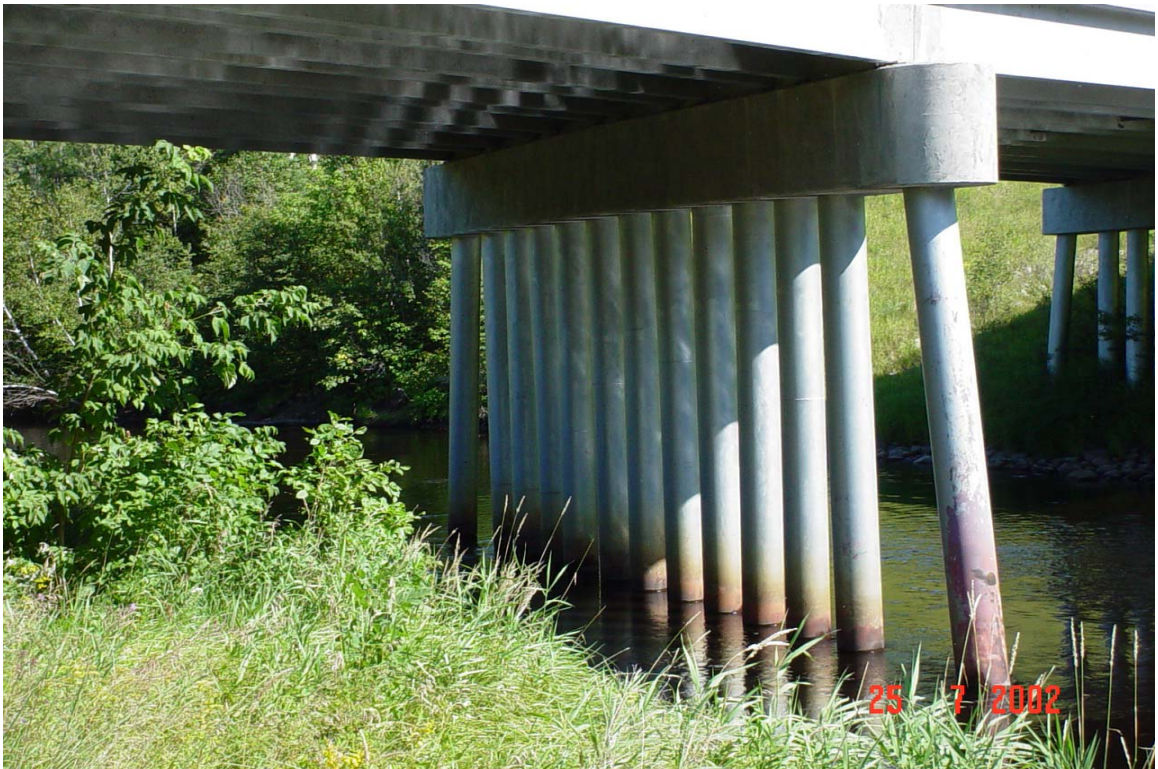
The substructure unit inspected at Bridge No. 36519, Pier 2, was found to be in good and sound condition with light corrosion covering 10 percent of the steel encased concrete piles from the waterline to the channel bottom. The channel bottom around the substructure unit appeared stable with 6- to 12-inch-diameter cobbles and no scour present.

- (A) The coating on the steel encased concrete piles exhibited 100 percent failure from 1 foot above the waterline to the channel bottom exposing the prime-coat and/or light corrosion on 10 percent of the pile surface area.

Photograph 2. View of Pier 2, Looking East.

- (A) Reinspect all substructure units underwater within the normal maximum (NBIS) interval of five (5) years.
